# HISTORICAL CHANGES ON SANDY SHORELINES IN VICTORIA

By ERIC C. F. BIRD\*

Dr Bird is a Reader in the Department of Geography, University of Melbourne, and the Chairman of the International Geographical Union's Commission on the Coastal Environment. This paper is based on a lecture given to the Royal Society of Victoria on 12th October, 1978.

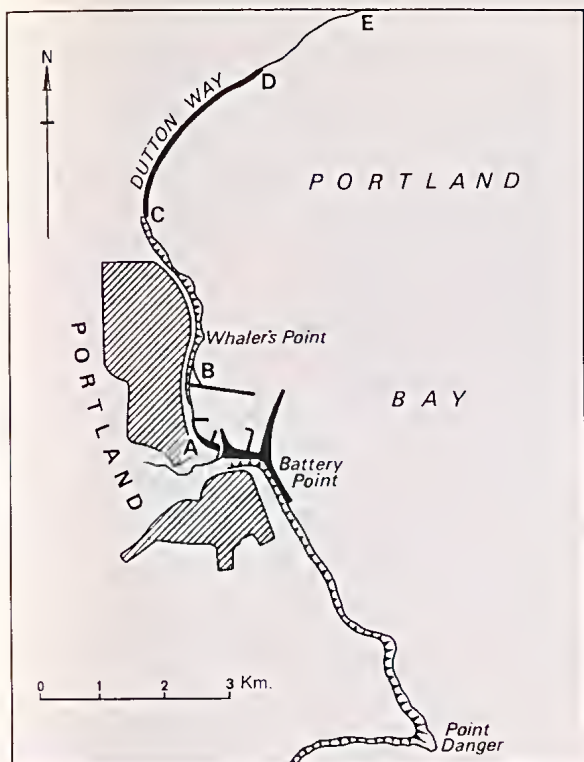
Fig. 2—Coastal features near Portland, Victoria.

Comparison of Mitchell's map with an air photograph taken in 1967 shows little change, except that there is now a more winding outlet from the river through a more extensive sandy threshold at the mouth, and the dunes immediately to the east have been cut back, and only partly rebuilt (J. F. Bird 1977).

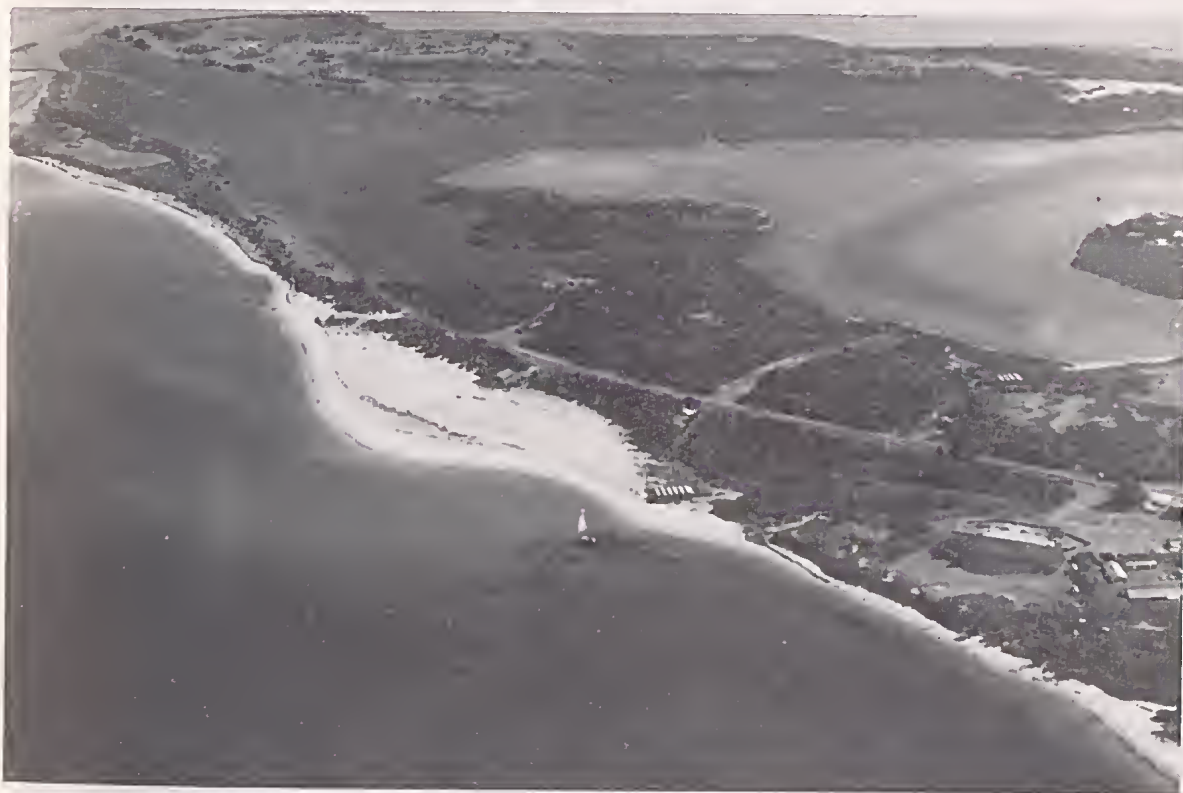
PLATE 1

The eastern shore of Swan Island, Port Phillip Bay, showing a migrating sand lobe. (*N. Rosengren, August 1973*)

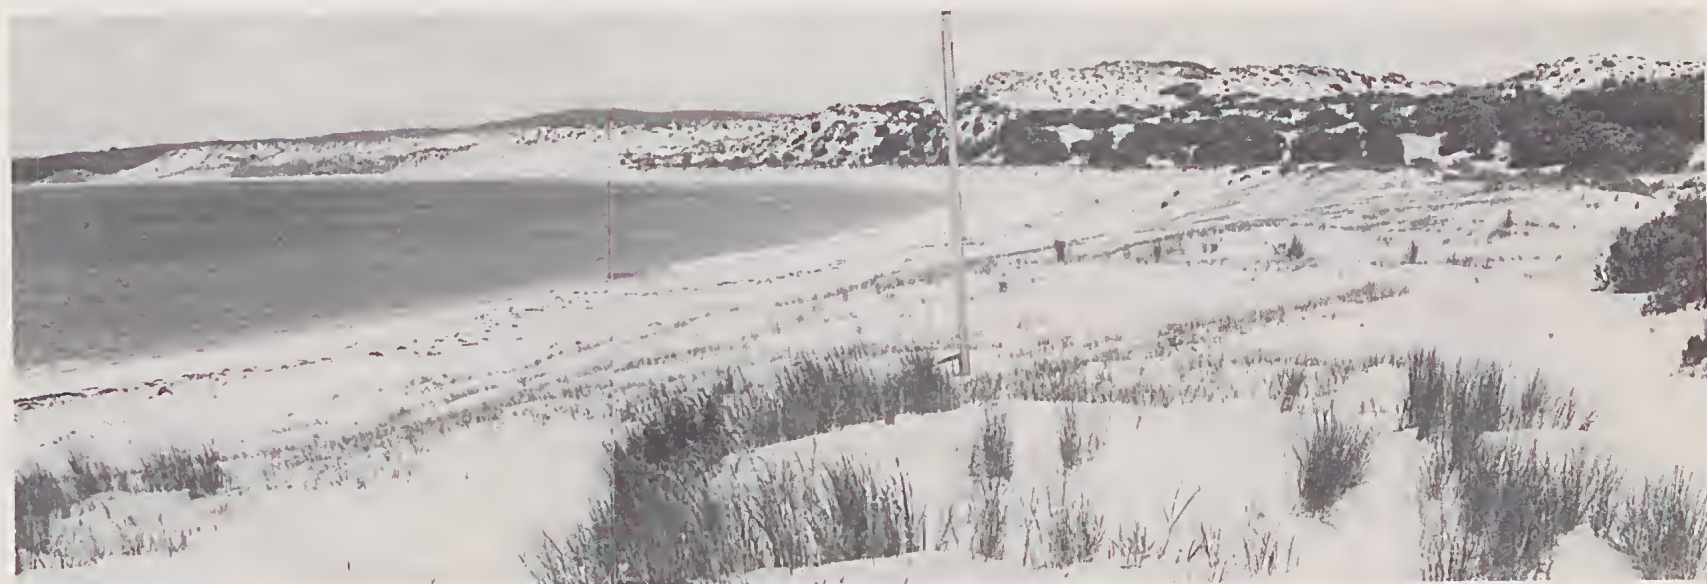
PLATE 2

The prograded sandy shoreline in Cleeland Bight, on the east coast of Phillip Island, fed with sand from the active Woolamai dunes in the background. (*E. C. F. Bird, February 1977*)

At the eastern entrance to Westernport Bay, sand is being supplied to the shores of Cleeland Bight by an active dune spilling from the isthmus north of Cape Woolamai. A combination of south-easterly wave action and inflowing tidal currents has carried this sand around the shores of the Bight, which have prograded by up to 300 m since this area was surveyed by Smythe in 1842 (Plate 2). Recently-built foredunes back sectors of this shoreline north to the road bridge, and there has been similar accretion on Davis Point, south of San Remo, where foredune growth proceeded in the interval between 1939 and 1973 air photography. The sand supply here is derived from shoals to the south, which are probably fed, in turn, by tidal redistribution of sand arriving in Cleeland Bight.

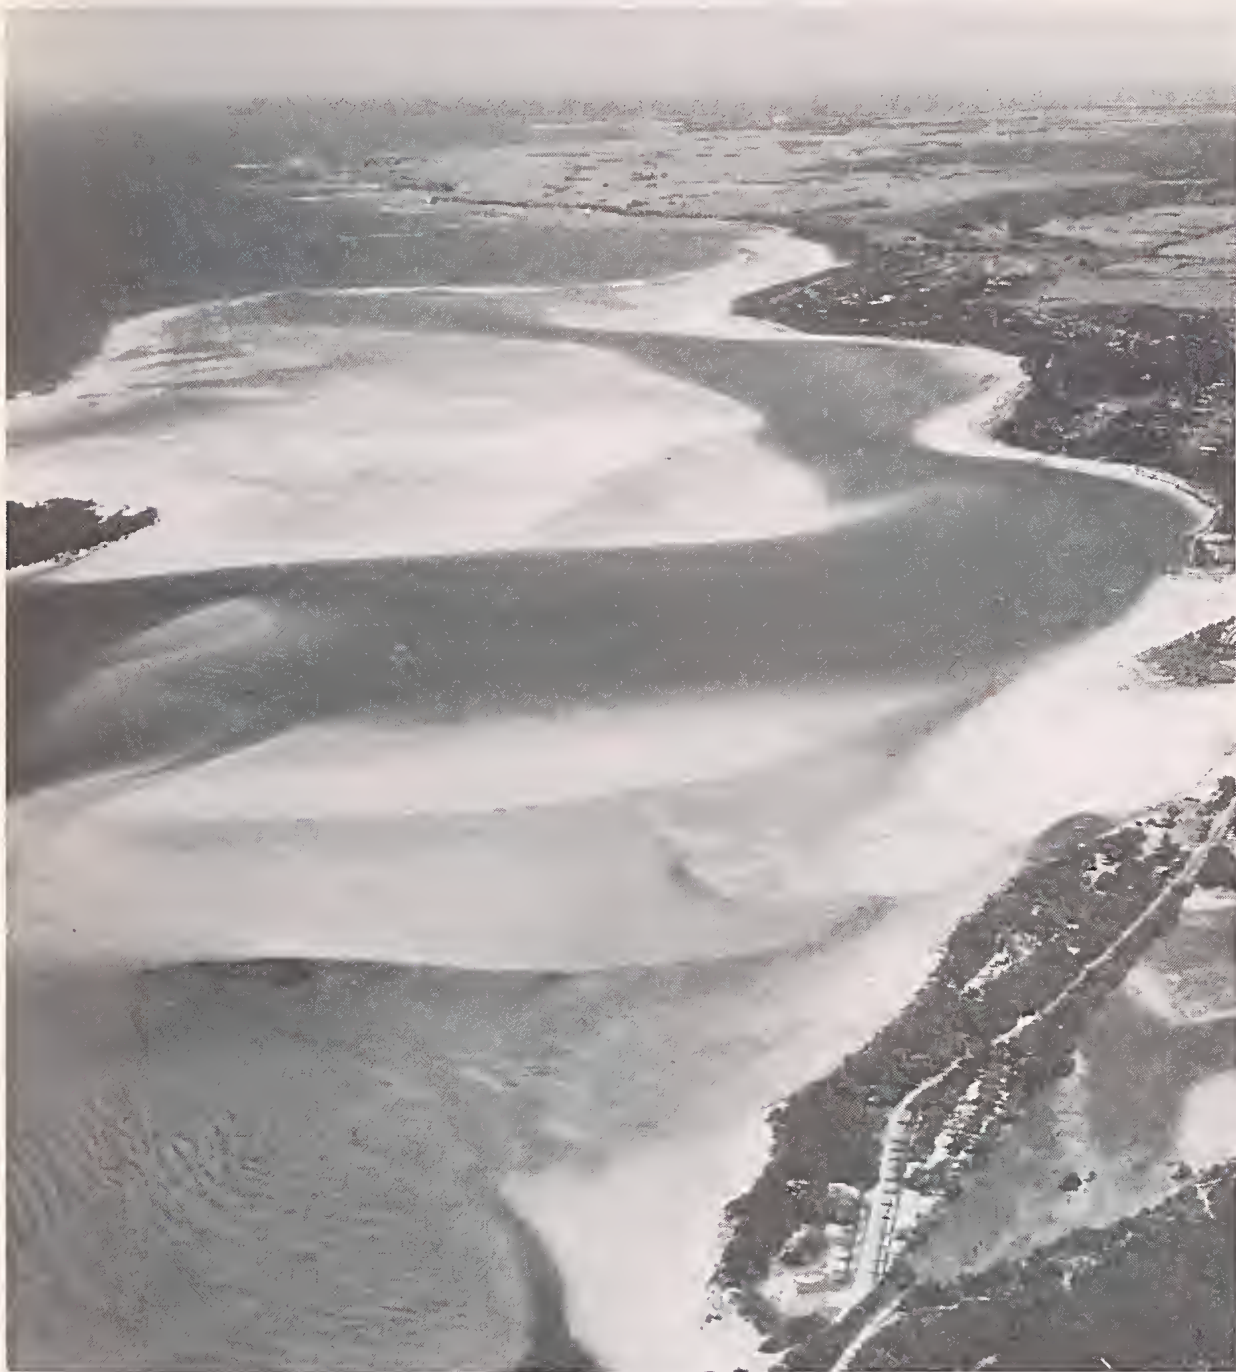
PLATE 3

Sand shoals moving into the entrance to Andersons Inlet at Inverloch. A spit is building up off Point Smythe, to the left, and lobes of sand are migrating along the Inverloch shore, to the right. (*K. G. Boston, March 1976*)

years. South of Inverloch new grassy beach ridges have added to the western shore of Venus Bay, and an extensive sandy flat has built up off Point Smythe, narrowing the tidal channel at the mouth of Andersons Inlet (Plate 3). A lobe of sand has moved in along the Inverloch shore since 1950 (Boston 1971) in much the

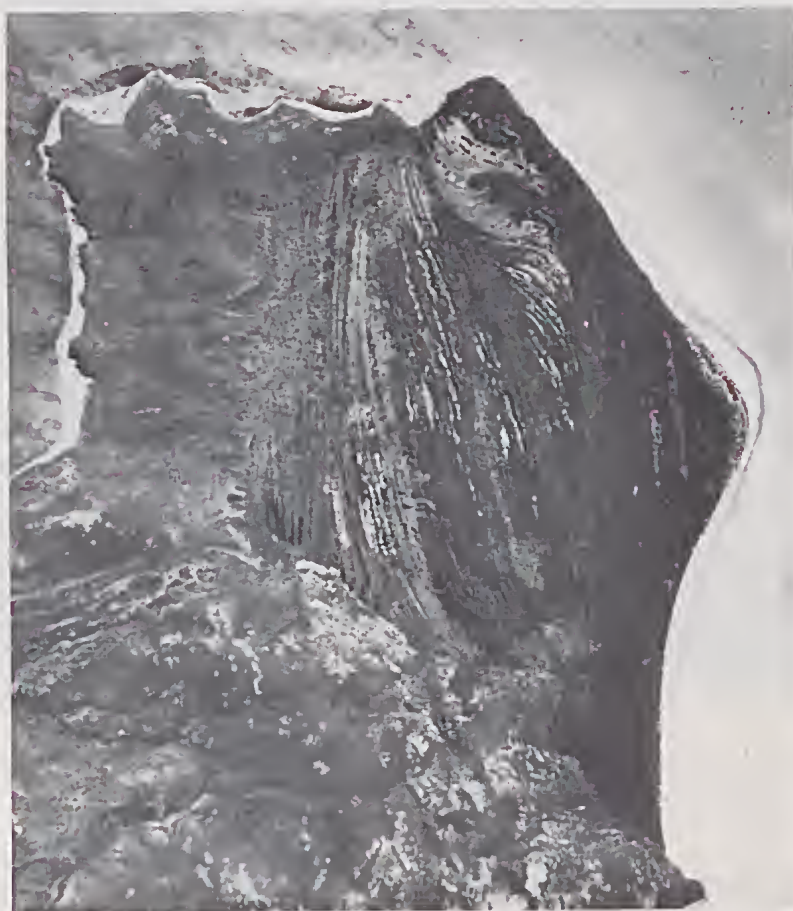
PLATE 4

Air photograph of northeast Wilsons Promontory. (Crown copyright reserved: Department of Minerals and Energy, Canberra, February 1965)

Sandy shorelines in each of the coves bordering Wilsons Promontory have receded during recent decades to produce cliffed dune margins, but on the northeastern corner there is an extensive beach ridge system, and a part of the coastline here has advanced as a new sandy foreland, while adjacent shores to the north and south have been cut back. A comparable bulging of the shoreline occurred at earlier stages, commemorated in the pattern of beach ridges farther inland (Plate 4). Such irregularities in growth probably result from changing patterns of refracted waves over the variable shoals off the adjacent entrance to Corner Inlet.

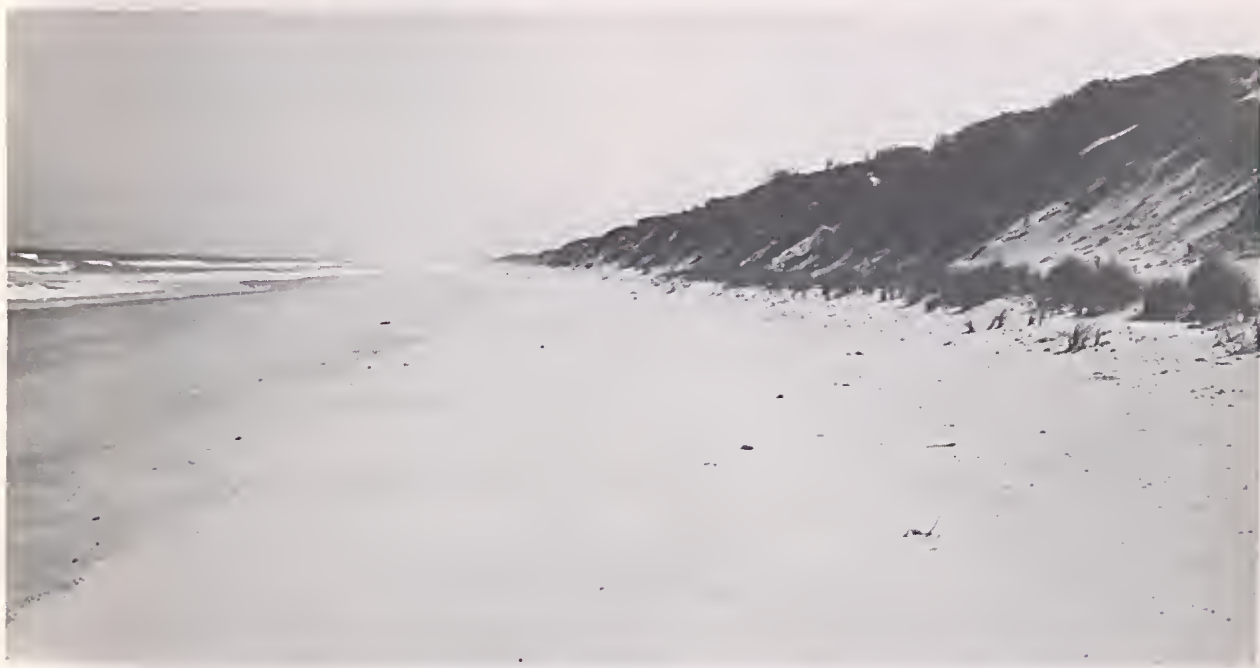
PLATE 5

A receding sandy shoreline: the Ninety Mile Beach near Ocean Grange. (*E. C. F. Bird, November 1965*)

The long sandy shoreline of the East Gippsland coast typically shows a cliffed dune margin to the rear of the present beach (Plate 5), and comparisons of the Coastal Survey Plans (1846-49) with air photographs taken in 1967 indicate that a recession of up to 150 metres has taken place. The Ninety Mile Beach is the seaward margin of an outer barrier that had previously prograded to form a succession of dune ridges. Such dunes develop as the result of alternations of shoreline advance and retreat (sequences of 'cut-and-fill' as described by Davies in 1957), and one interpretation of the present situation could be that a retreat phase has lately prevailed, and will duly give place to another advance phase, when a new and persistent sand ridge will be added to prograde the shoreline. However, the present retreat phase has been on a much larger scale

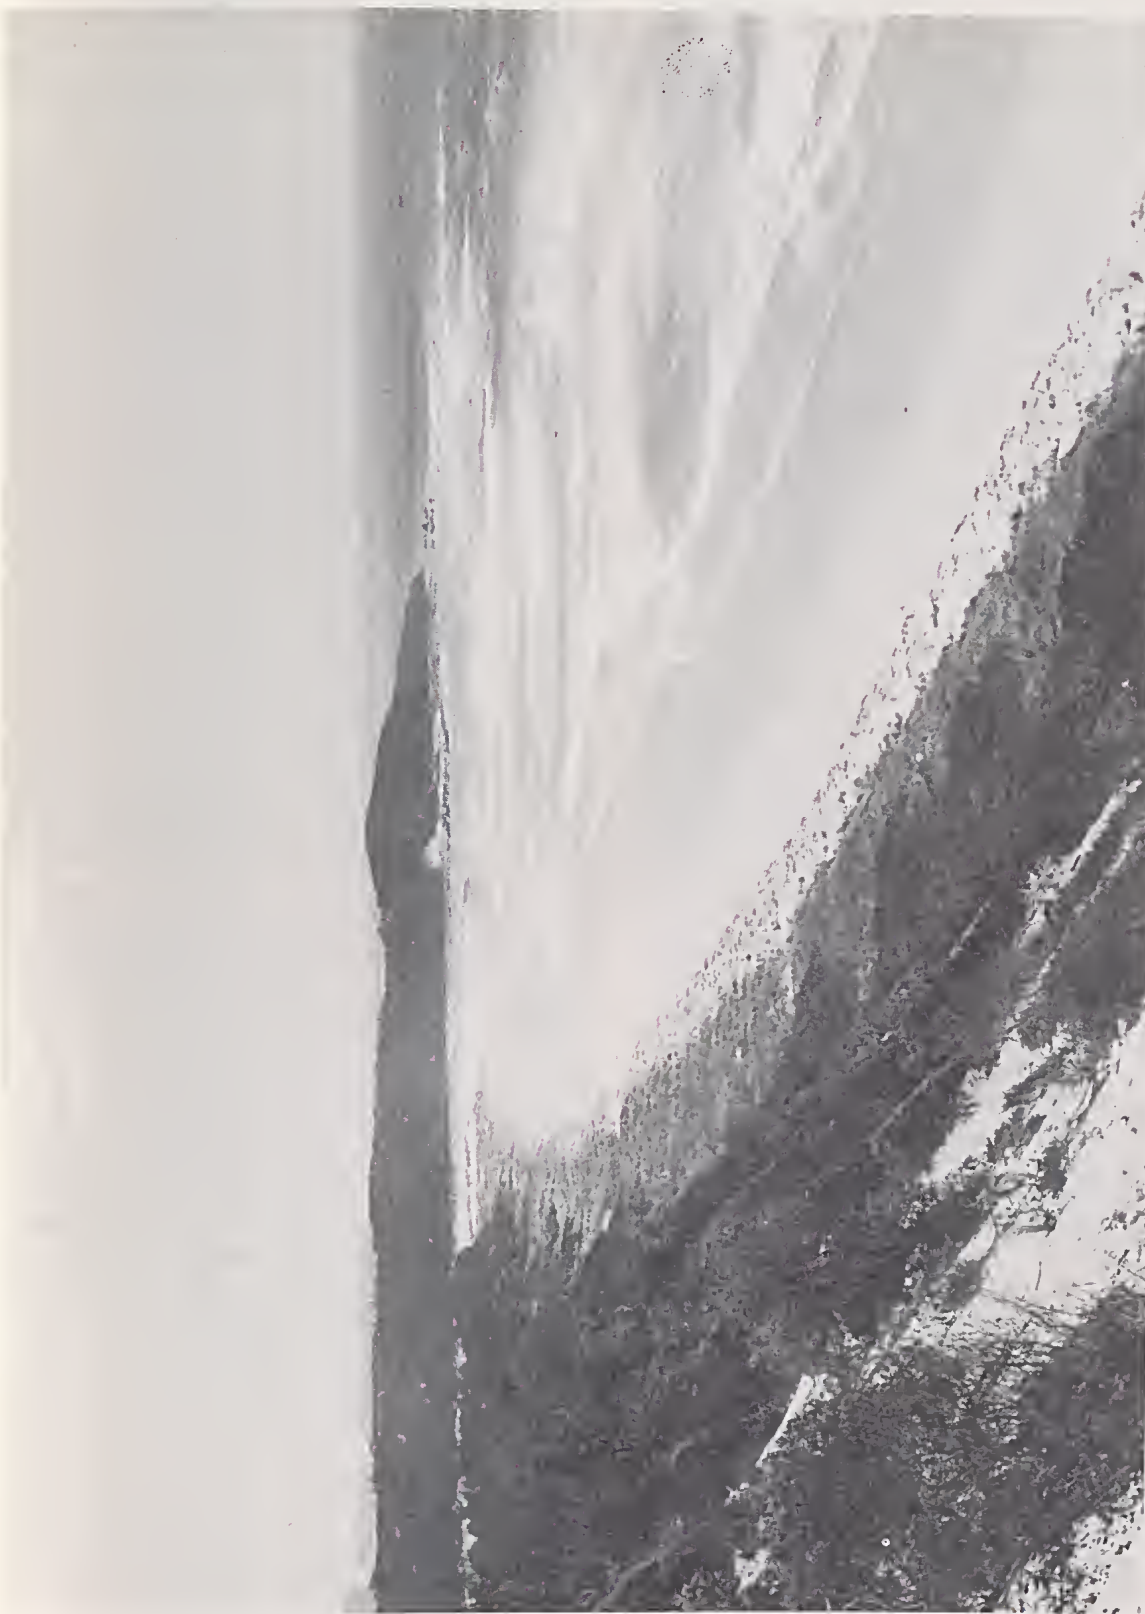
PLATE 6

The prograded grassy sand terrace in the bay at Wingan Inlet, shortly before it was cut away by storm waves. (*N. Rosengren, November 1973*)
